INDOOR AIR QUALITY ASSESSMENT

**Revere Public Library
179 Beach Street
Revere, Massachusetts**

Prepared by:
Massachusetts Department of Public Health
Bureau of Environmental Health Assessment
July, 2001

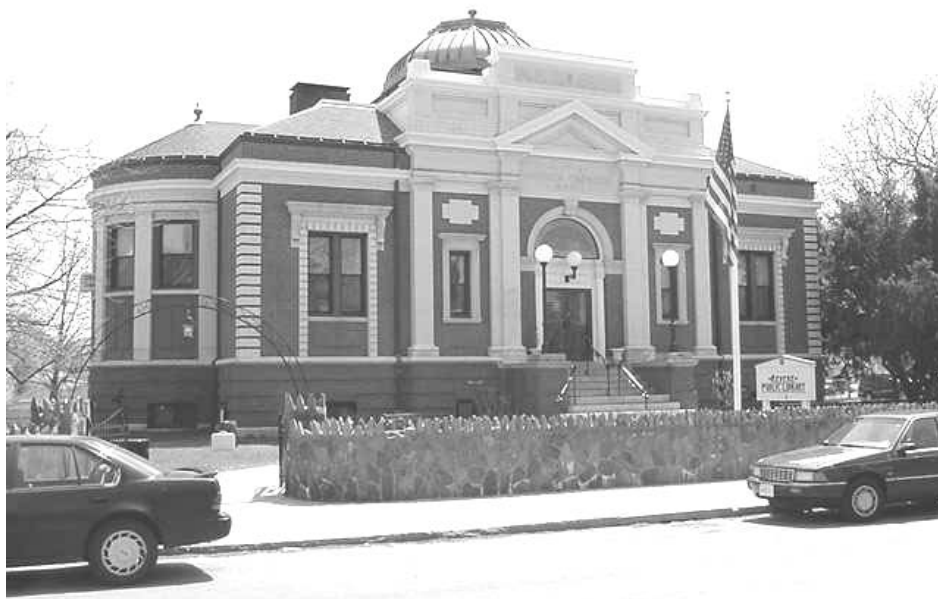
Picture 1

The library is a two-story red brick and steel frame structure built in 1902 (see Picture 1). The second floor contains a rotunda and is currently used for storage. The first floor contains the circulation desk, reading areas and main stacks of the library. The basement/ground floor contains the periodical section, employee break room, boiler room and the children's library, which is located adjacent to the boiler room.

Revere Public Library (2001), Built in 1902
